**MISHAPS WITH OXYGEN IN NASA OPERATIONS**

by Paul M. Ordin  
Lewis Research Center  
Cleveland, Ohio

**TECHNICAL PAPER** proposed for presentation at  
Oxygen Compressors and Pumps Symposium  
sponsored by the Compressed Gas Association  
Atlanta, Georgia, November 9-11, 1971

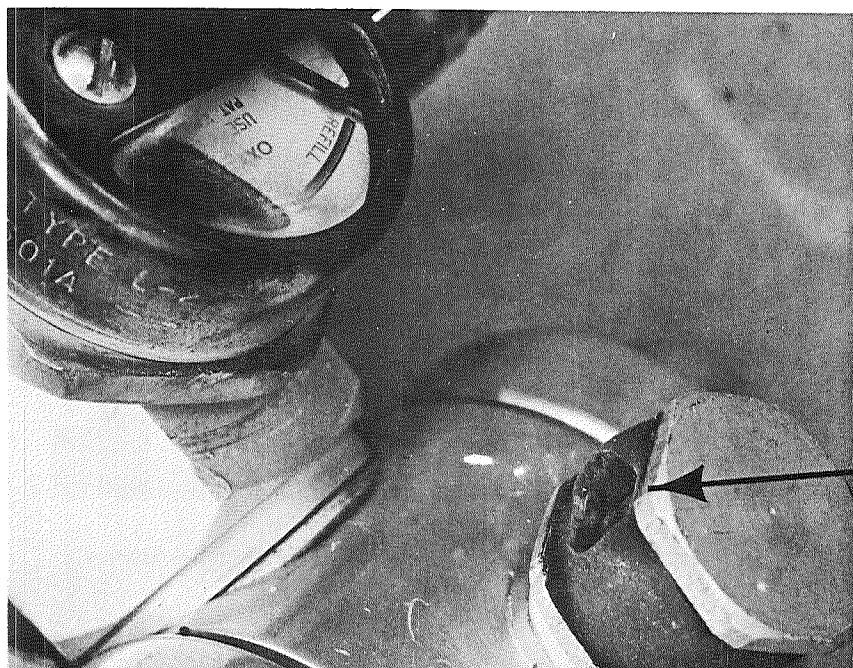
The mishap was caused by procedural deficiencies which did not provide sufficient quality control; by the use of incompatible materials and by system design limitations resulting in galling between the stainless steel inlet valve camshaft and aluminum housing. The galling of the metals was most likely responsible for the metal particles found in the system. Redesign of the inlet valve camshaft assembly and the installation of a filter screen in the regulator are minimum changes required. The various rubber and plastic soft goods used in the regulator are listed in Table 1. With the exception of the TFE Teflon on the regulator inlet valve seat, all the materials are considered incompatible with high pressure oxygen systems.

Figure 6. - External view of resuscitator regulator illustrating ruptured safety valve and flash damage to the pressure gauge.

resuscitator were unacceptable. Acceptable substitutes have been recommended.

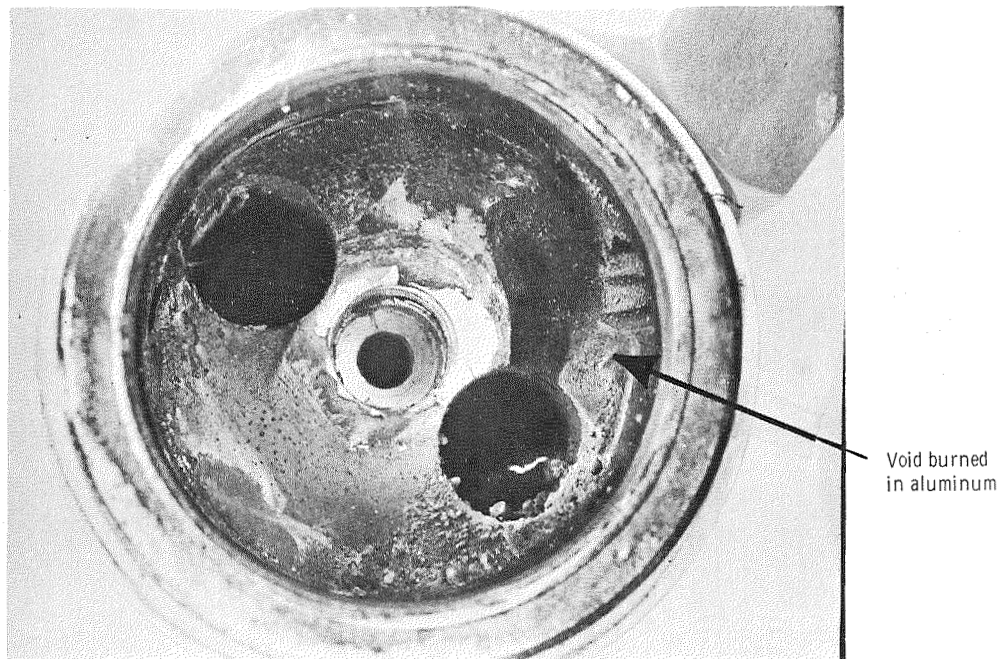
equipment for launch facility operations. The probable source of the fire was the regulator primary seat made of nylon. Ignition was most likely promoted by small metal particles which were found in the system. A schematic diagram of the resuscitator regulator is shown in Figure 5 and a photograph of the ruptured safety valve in Figure 6. A view into the regulator body illustrating the burned portions is shown in Figure 7.

Figure 7. - View of inner surface of aluminum regulator body.

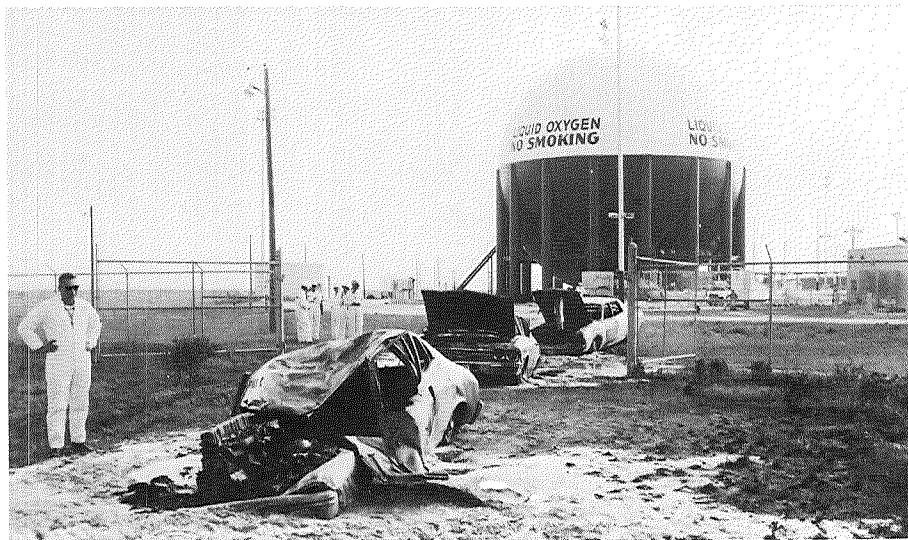
A photograph showing the burned cars and their positions with respect to the fence and oxygen tank is shown in Figure 10. Detail comments from the official report on the accident (ref. 8) concerning results of the examination of each of the cars included the following:

- (a) The fire was first observed by the operator in the engine compartment which upon examination indicated the most intense heat. It is believed that the point of ignition occurred in the engine compartment.
- (b) The driver stated that vehicle had been operated for a sufficient time to be at normal operating temperature and that the vehicle ignition had been off for approximately five minutes when fire was first noticed.
- (c) Normally, engine metal under the above conditions would attain an exhaust manifold temperature of above 600°F or above. Underhood temperatures increase after engine shutdown due to stoppage of the entire cooling system. It is believed that the increased, or high, temperatures caused vaporization of gasoline from the

Figure 10. - Burned cars in relation to oxygen tank and fence.

Working or operating vehicles in oxygen clouds or oxygen enriched environments is hazardous since it provides an increased potential for ignition. The minimum spark energy required for ignition, the flash point and the autoignition temperature are all decreased. The deficiencies responsible for the accident included a combination of system design, procedural and training limitations. The overall loading and dumping systems should include methods of verifying, tracking and control of oxygen clouds. Procedures for alternate routes for emergency vehicles and fire control of personnel entry into oxygen clouds should be prescribed.

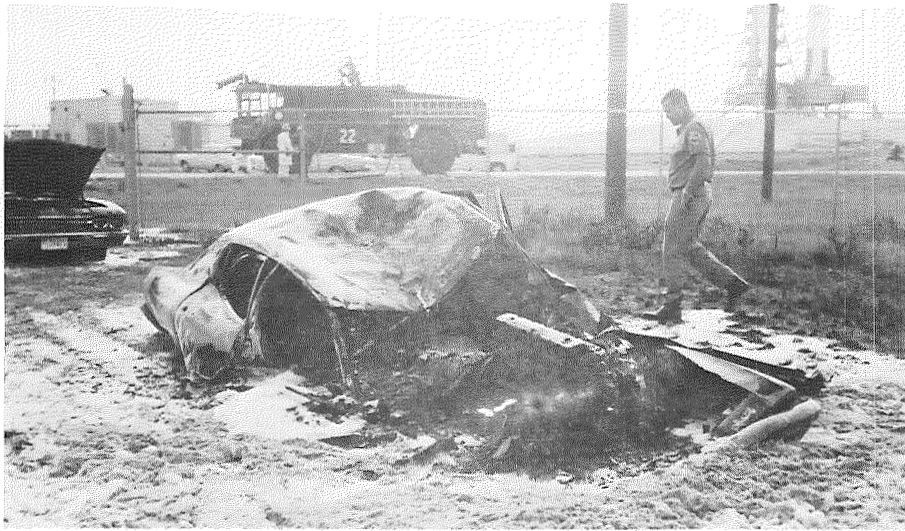
Figure 11. - Damaged car number 1.

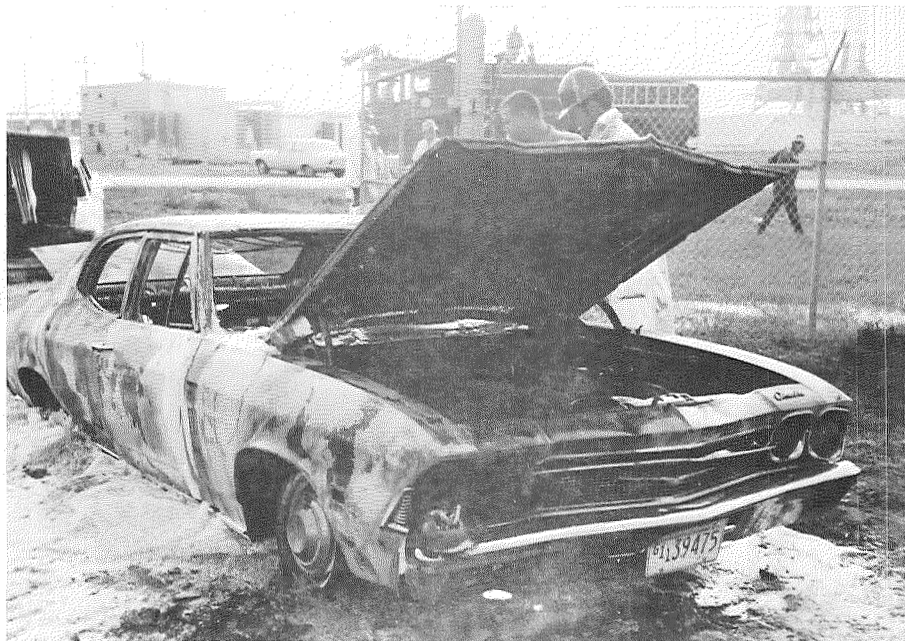
Figure 12. - Damaged car number 2.

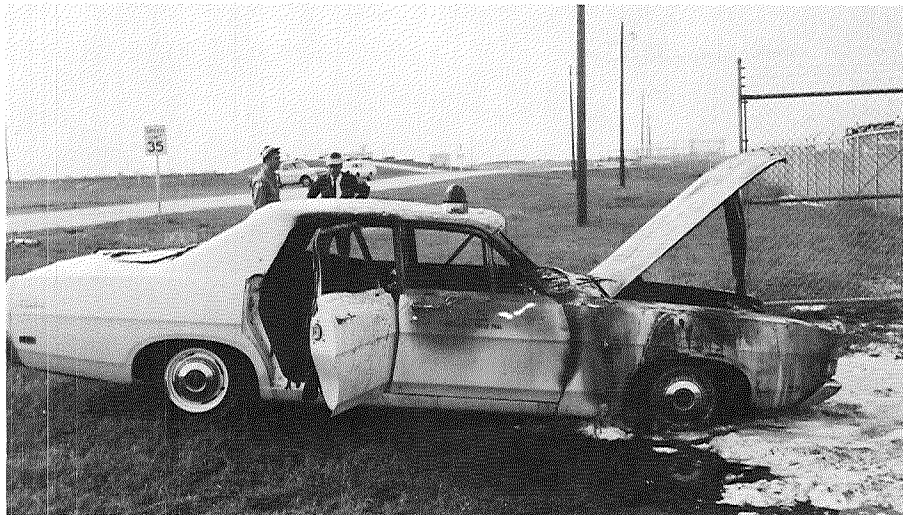
Figure 13. - Damaged car number 3.

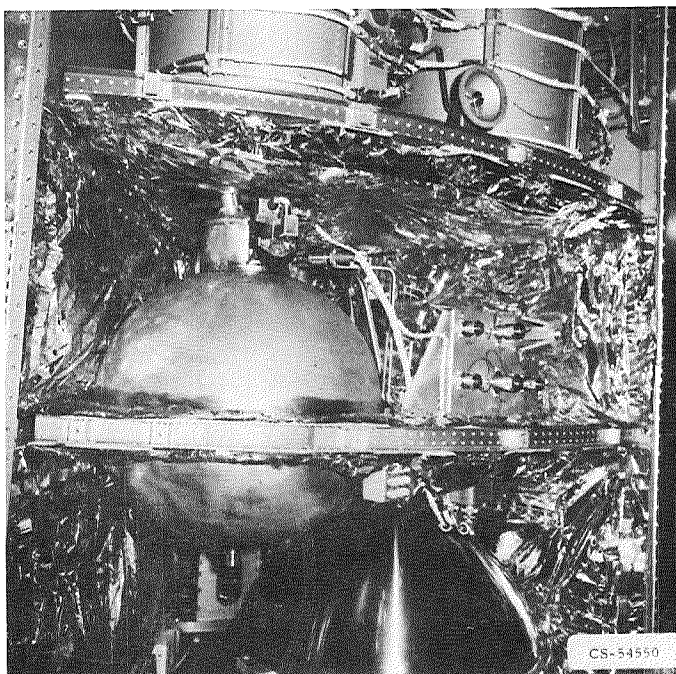
CS-54828

The insulation on the power wires may have become abraded due to vibration of the conduit and the rubbing of the wires against each other. The method of assembling leads into the conduit may have introduced strains into the wires causing increased insulation wear. These conditions could then lead to situations where sufficient energy, produced by shorting power leads, could ignite the surrounding Teflon. Most probably, the Teflon insulation fire progressed into the electrical conduit tubing at the top of the tank, opening the tank to the service bay. With the burn-through of the conduit, the pressure increased in the bay resulting in separation of the panel which enclosed the bay. The panel separation from the bay probably caused sufficient shock to close the oxygen supply valves. In all likelihood, the oxygen system (in tank 1) developed a leak either as a result of the shock when the panel separated or from the dynamics of the events associated with the failure of the tank 2 electrical conduit. A photograph of the oxygen tank in the service module bay is shown in Figure 19.

Figure 20. - Damaged Teflon insulation.

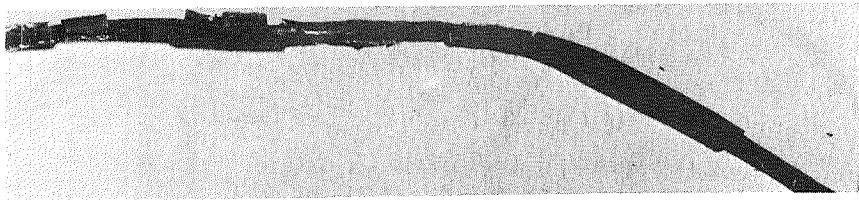
CS-54827

were connected in series with each of the heating elements to avoid excessive temperatures. The heater circuit would be automatically opened when the internal heater tube wall temperature reached 90°F and closed at 70°F. The use of the heaters to assist in detanking required a manual mode of operation which resulted in the switches opening under a load at twice the normal operating conditions for each heater. Tests showed that opening the switches under these conditions would fuse the contacts closed at the instant of power interruption. Tests have verified that with the heater on, for the duration experienced during prelaunch operations, fan motor wire insulation would be severely degraded. A photograph of the fan motor wire damage from simulated heater tests is shown in Figure 20. A fused thermal switch control obtained under simulated tests is shown in Figure 21.

Figure 21. - Fused thermal switch control.

- (a) Redesign and replacement of O<sub>2</sub> tanks, and supply systems in the service module.
- (b) Provision of additional battery power for backup operation of the command service module.
- (c) Review and refinement of Apollo systems for contingency operation and contingency plans.
- (d) Review and analysis of all liquid oxygen systems in Apollo and other systems.
- (e) Review and analysis by all NASA agencies for hazards and unidentified deficiencies in all ground based as well as flight systems using LOX and other oxidizer.
- (f) Renewed awareness of the criticality of metals and materials combined with heat/ignition sources in oxygen systems.
- (g) Increased review of anomalies when they occur.
- (h) Closer quality control contacts to be maintained with vendors, subcontractors and suppliers.
